16th ROAD SAFETY

Motorway Workers safety under extreme weather conditions

DIMITRIOS MANDALOZIS

AEGEAN MOTORWAY SA

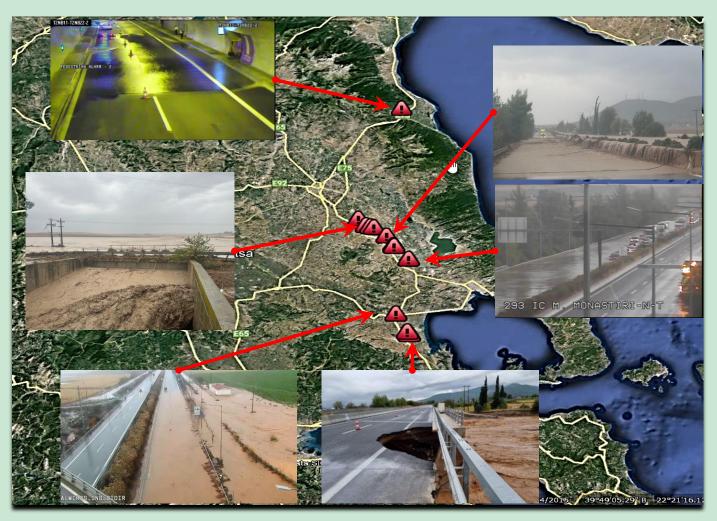
Flooding incidents: Phase A

Phase A – Sudden & Extreme heavy rain (2 days)

Impact

- Over a length of 100 km
- Severe damage on embankments and pavement
- Water inflow in Tunnel T2
- Collapse of Telecom service provision at the area
- Toll suspensions

Actions

- Traffic management measures for traffic deviation
- Activation of Disaster Recovery Site Communication through company's Backbone Network
- Visual inspection of all assets

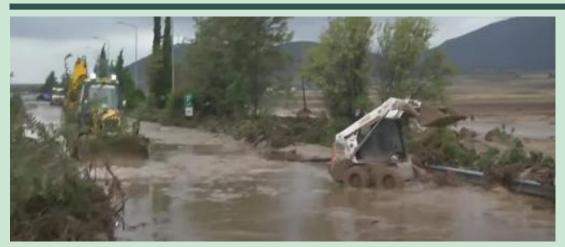
Near miss incident in Phase A

Near miss incident

- An employee operating a skid steer loader (Bobcat) during pavement cleaning works had to abandon it due to rising water level
- Constant communication with MMC

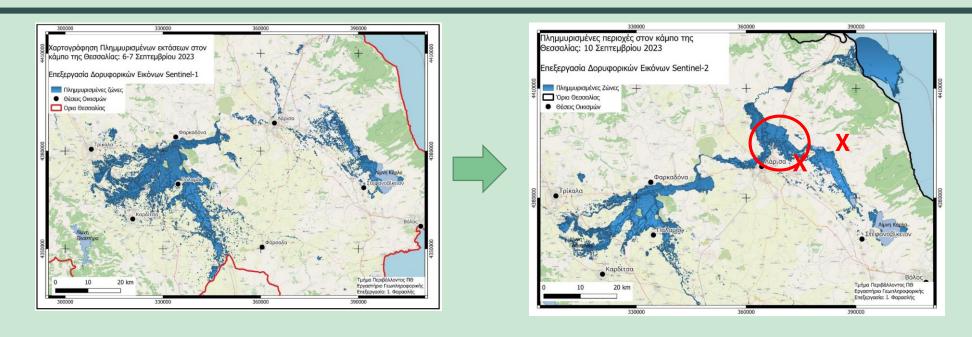
Flooding incidents: Phase B

Phase B – Gradual rise of the waters (3 consequent days)

- A couple of days after the heavy rainfalls, Aegean Motorway dealt with huge quantities of storm water, moving in Thessaly Plain from W → E
- An area over 5 km long was severely affected
- All traffic was suspended for more than a week. The consequent diversion increased travel time by 25%
- Toll suspensions applied at affected areas

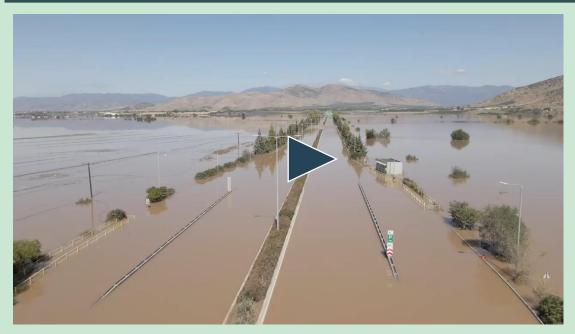
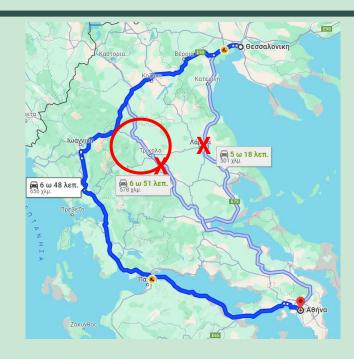
Flooding incidents: Phase B

Phase B – Gradual rise of the waters (3 consequent days)

- A couple of days after the heavy rainfalls, Aegean Motorway dealt with huge quantities of storm water, moving in Thessaly Plain from W → E
- An area over 5 km long was severely affected
- All traffic was **suspended** for more than a week. The consequent diversion increased travel time by 25%
- Toll suspensions applied at affected areas

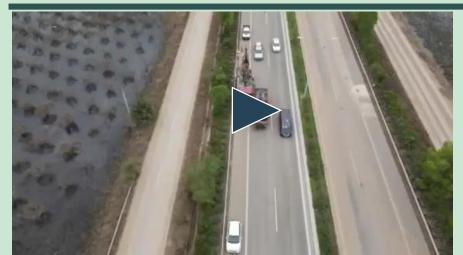
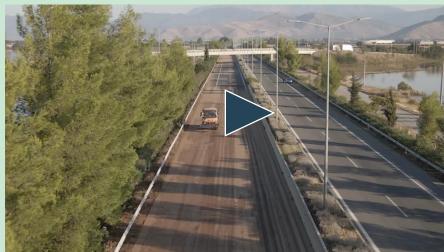
New standard for infrastructure monitoring

The 5km section of the motorway was fully reopened to traffic after a month.

Traffic was reinstated in three phases, with the implementation of specialized methodology in order to verify the operational status of the motorway. This methodology among others included:

- Visual inspections of assets
- Slip testing (with British Pendulum and Micro Griptester devices)
- Smoothness checks (with a special vehicle carrying special electronic equipment)
- Pavement bearing capacity tests (with the Benkelman beam test)
- Geotechnical tests carried out by boreholes
