# 18TH ROAD SAFETY CONFERENCE

Evaluating the impact of road safety measures: Before and After studies in the Ascendi network

João Neves

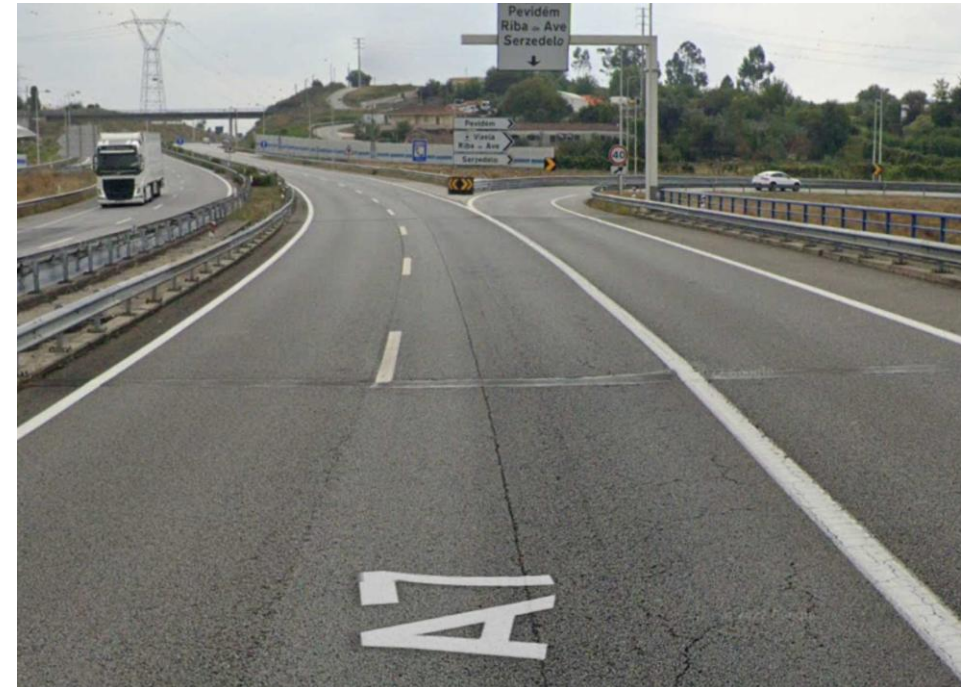
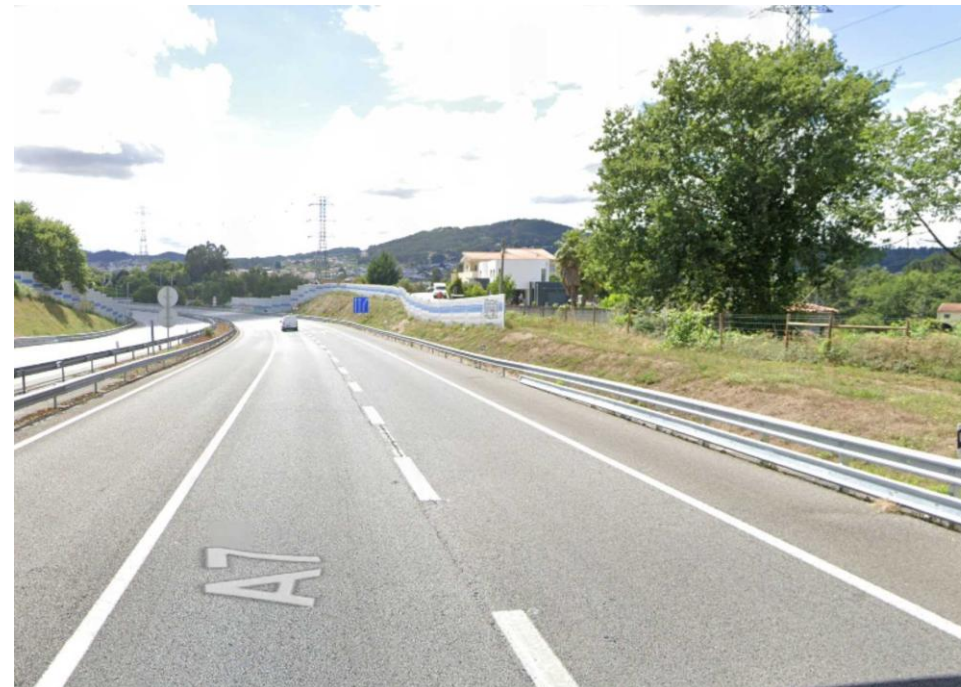
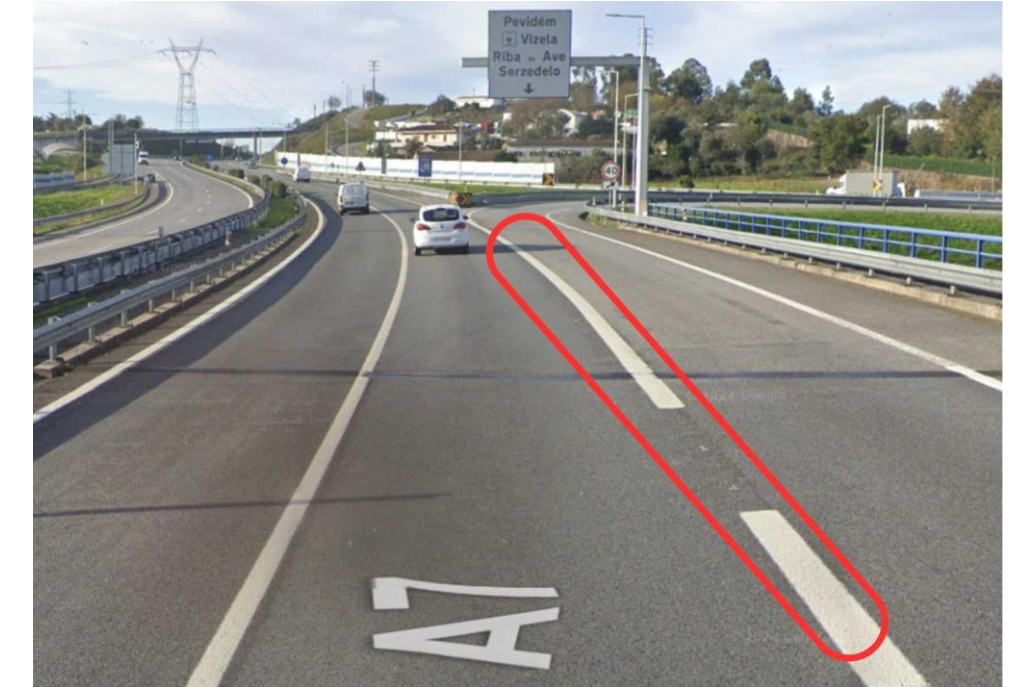
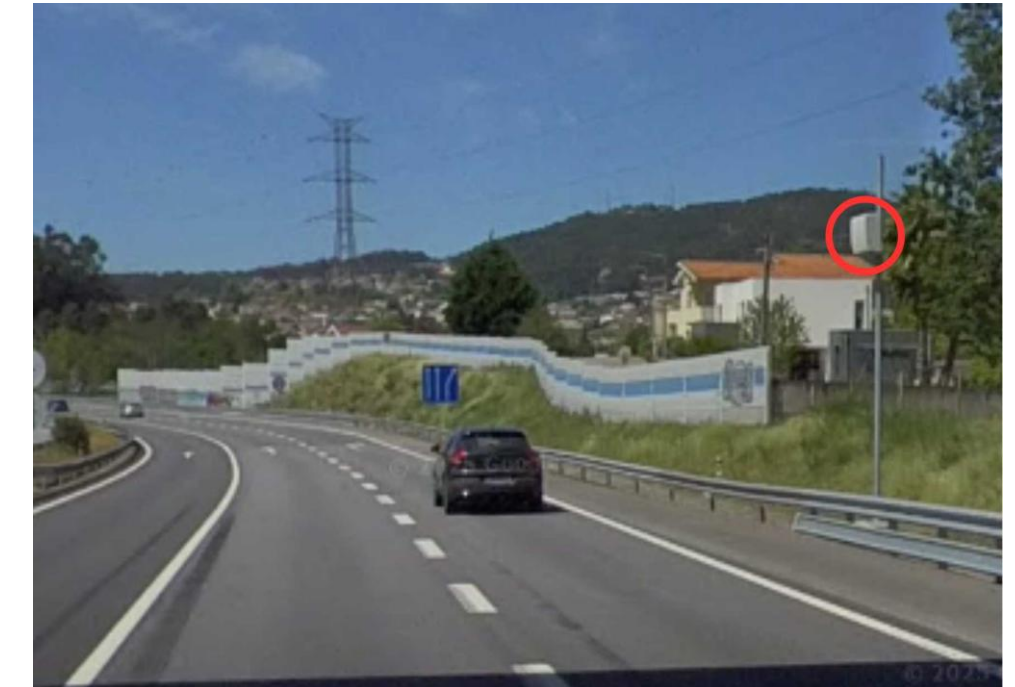
# Seide – Ave - Selho

Norte concession, A7 motorway, direction:  
decreasing from PK 33+500 to 33+000

- ▲ 29 Total crashes
- ▲ 5 Injury crashes
- ▲ 72,5% of crashes were run-offs
- ▲ 85% of crashes occurred on wet pavement

Instantaneous speed  
camera at PK 33+250

Milling and applying a new  
wearing layer

Improvement of horizontal  
and vertical signage

Implementation was completed on 01/03/2022.  
The instantaneous speed camera was installed in  
February 2023.

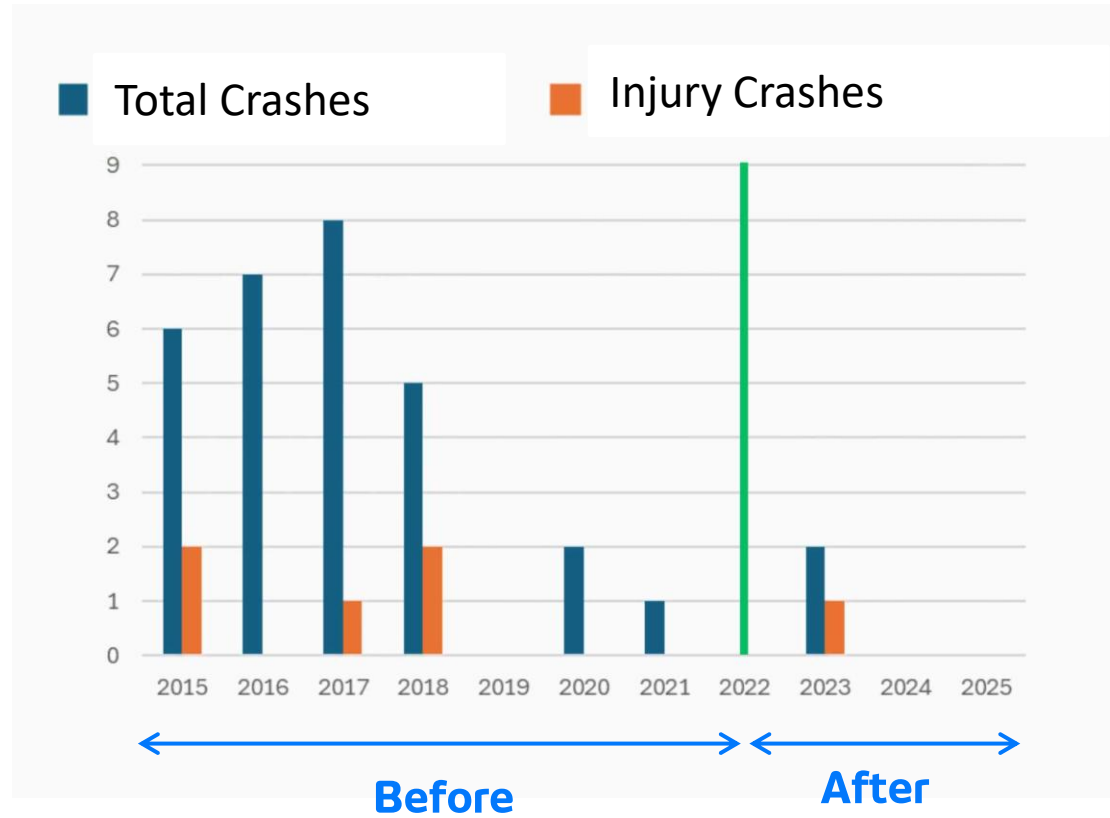
## Crash History

— Implementation date: 01/03/2022  
 "After" Period: 3 year and 10 months

Before	After	Expected After	Variation	Crash Variation (%)
Crashes	29	2	16	-14	-88%
Injury crashes	5	1	3	-2	-69%

Before	After	Weighted AADT Before*	Weighted AADT After	Expected After*	Variation	Variation(%)
Crashes	29	2	4996	9702	30	-28	-93%
Injury crashes	5	1	4996	9702	5	-4	-83%

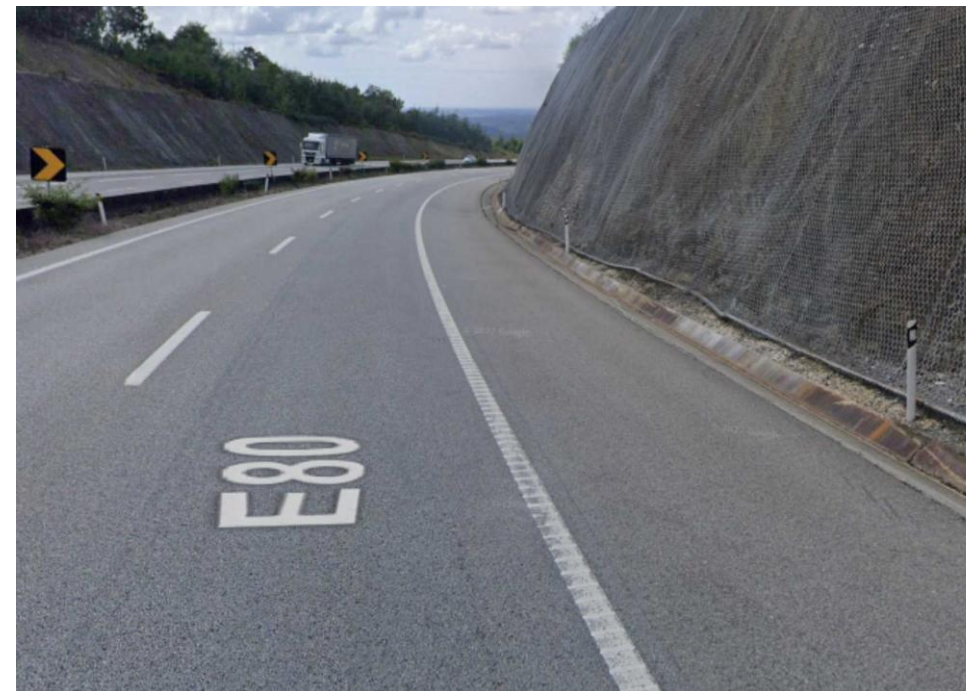
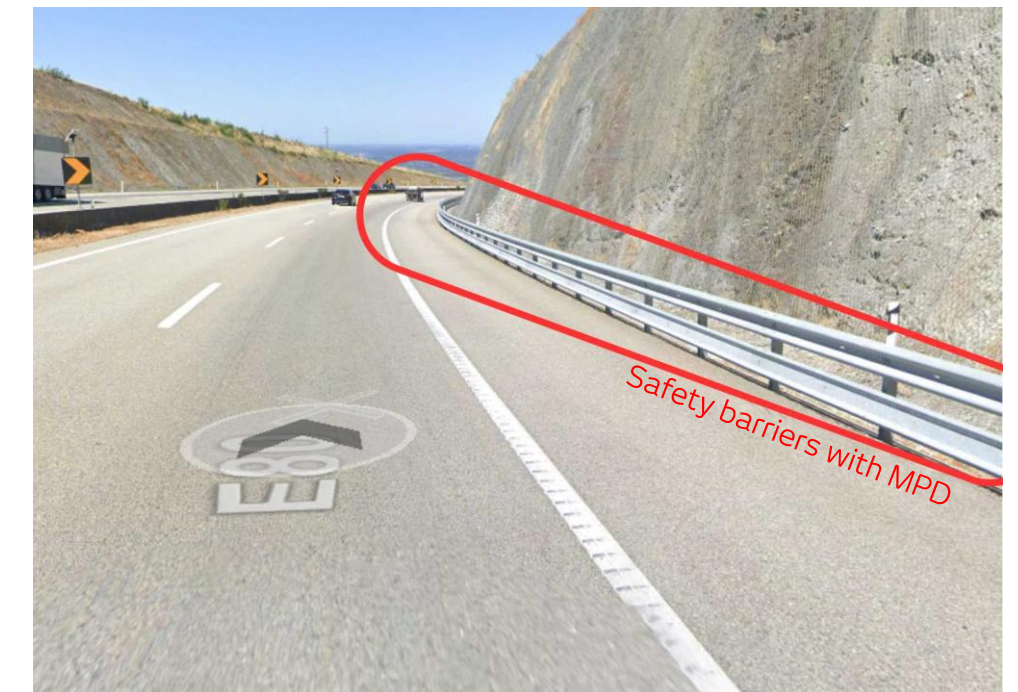
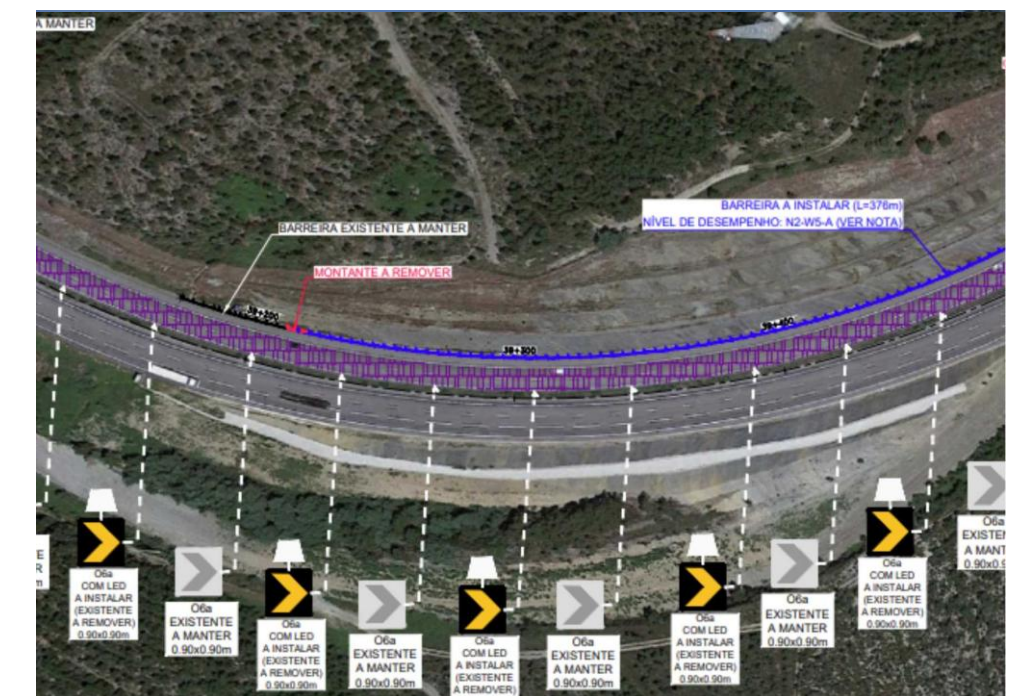
# Carvoeiro - Talhadas

Beira Litoral e Alta concession, A25 motorway,  
direction decreasing from PK 39+600 to 39+000

- ▲ 20 total crashes
- ▲ 5 injury crashes
- ▲ 100% of crashes are run-offs

Average speed camera between PK 42+469 and PK 37+600
-   Pavement shot blasting
-   Installation of safety barriers with MPD
-

Installation of Chevrons signs with alternating LED's

Implementation was completed on 20/12/2021.  
The average speed camera was installed in Agosto 2023.

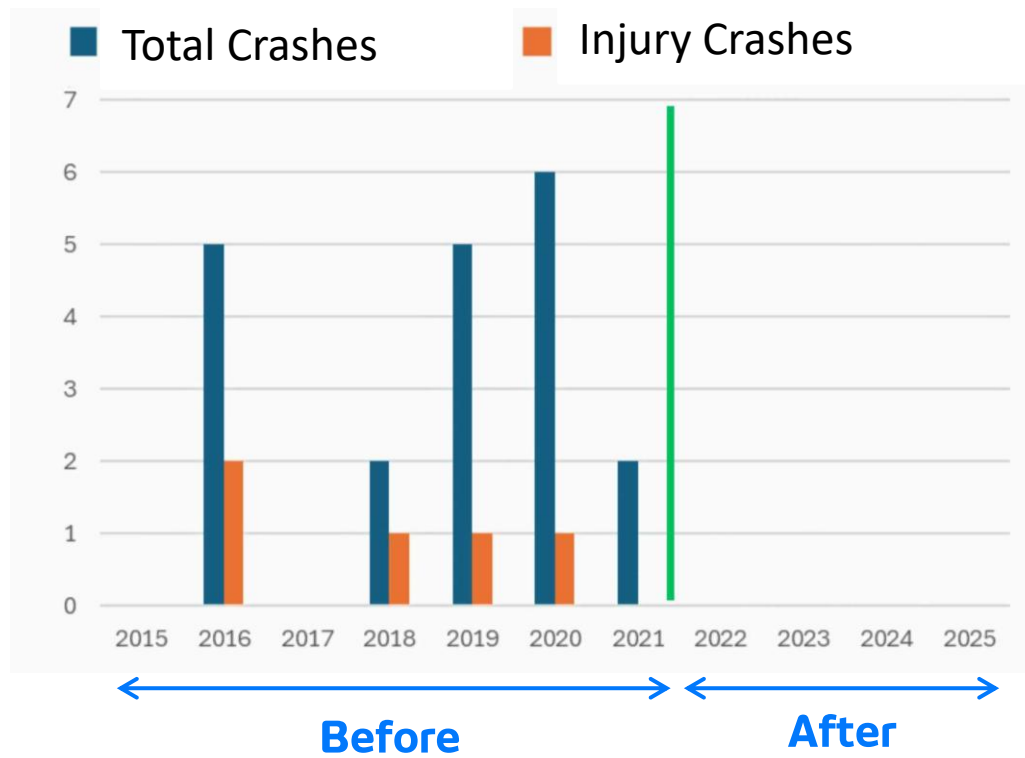
## Crash History

— Implementation date: 20/12/2021  
 "After" period: 4 year and 11 months

Before	After	Expected After	Variation	Crash variation (%)
Crashes	20	0	12	-12	-100%
Injury crashes	5	0	3	-3	-100%

Before	After	Weighted AADT Before	Weighted AADT After	Expected After	Variation	Crash variation (%)
Crashes	20	0	6238	7631	14	-14	-100%
Injury crashes	5	0	6238	7631	3	-3	-100%

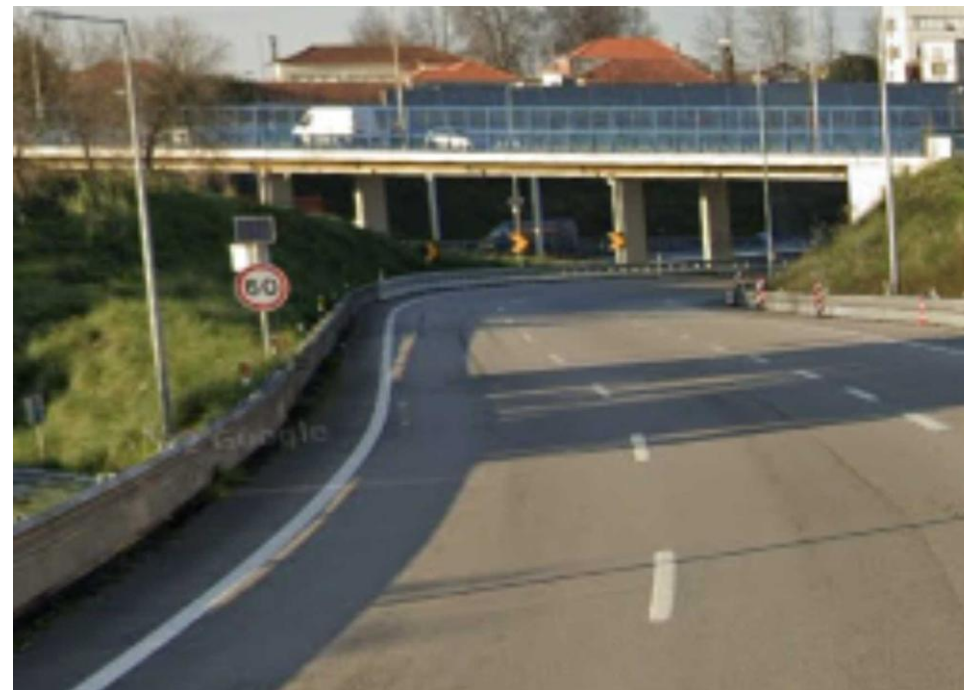
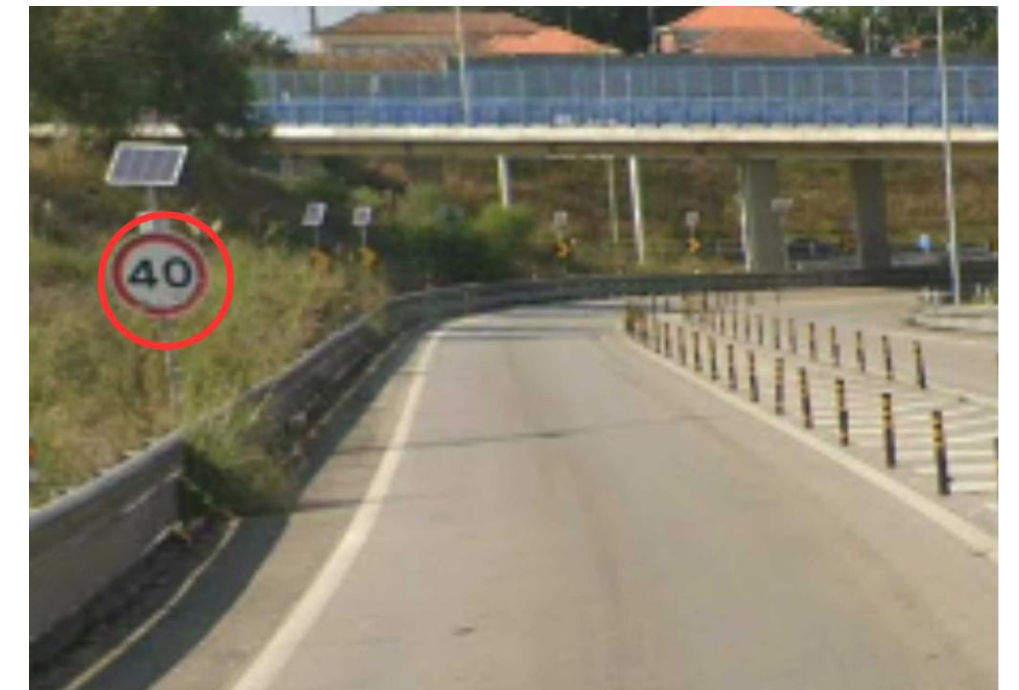
# Sendim Node, link H

Grande Porto Concession, A4 Motorway, link H from Sendim Node

- ▲ 47 total crashes and 8 injury crashes
- ▲ 11 Minor injuries
- ▲ 94% of crashes were run-offs
- ▲ 89,4% of crashes occurred on wet pavement

Reduction of Link H from 2 lanes to 1 lane

Redution of the legal speed limit from 60 km/h to 40 km/h

Improvements to horizontal and vertical signage

Milling and replacement of the wearing layer

Implementation was completed on 01/09/2022.

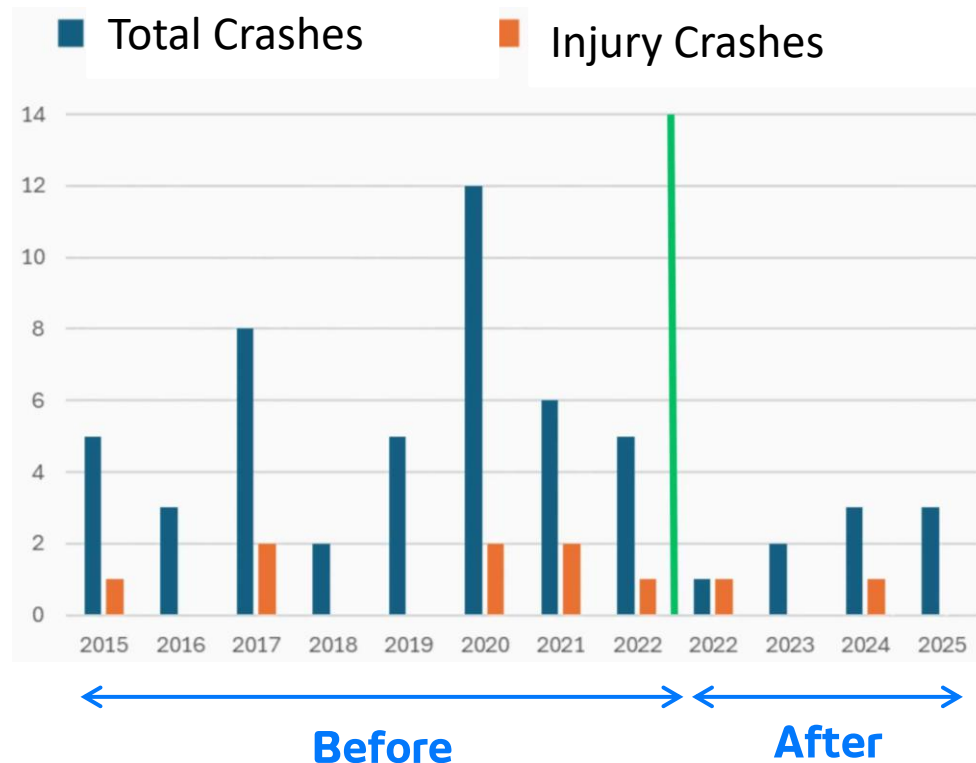
## Crash History

— Implementation date: 01/09/2022  
 After Period: 3 year and 3 months

Before	After	Expected After	Variation	Crash Variation (%)
<b>Crashes</b>	47	9	20	-11	-57%
<b>Injury Crashes</b>	8	2	3	-1	-49%

Before	After	Weighted AADT Before	Weighted AADT After	Expected After	Variation	Crash Variation (%)
<b>Crashes</b>	47	9	14465	17742	25	-16	-65%
<b>Injury Crashes</b>	8	2	14465	17742	4	-2	-57%

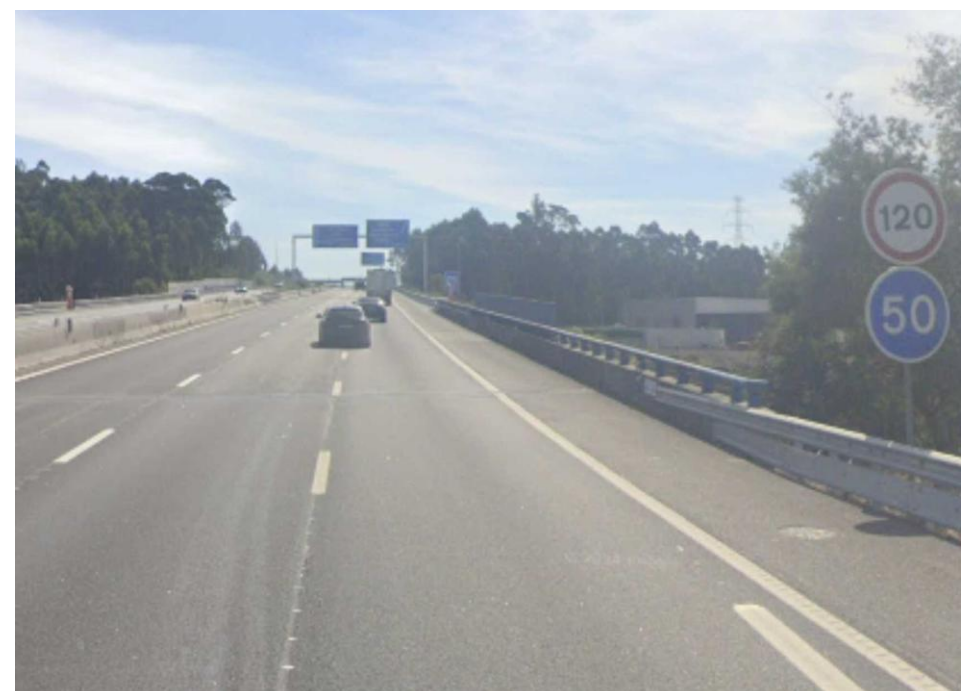
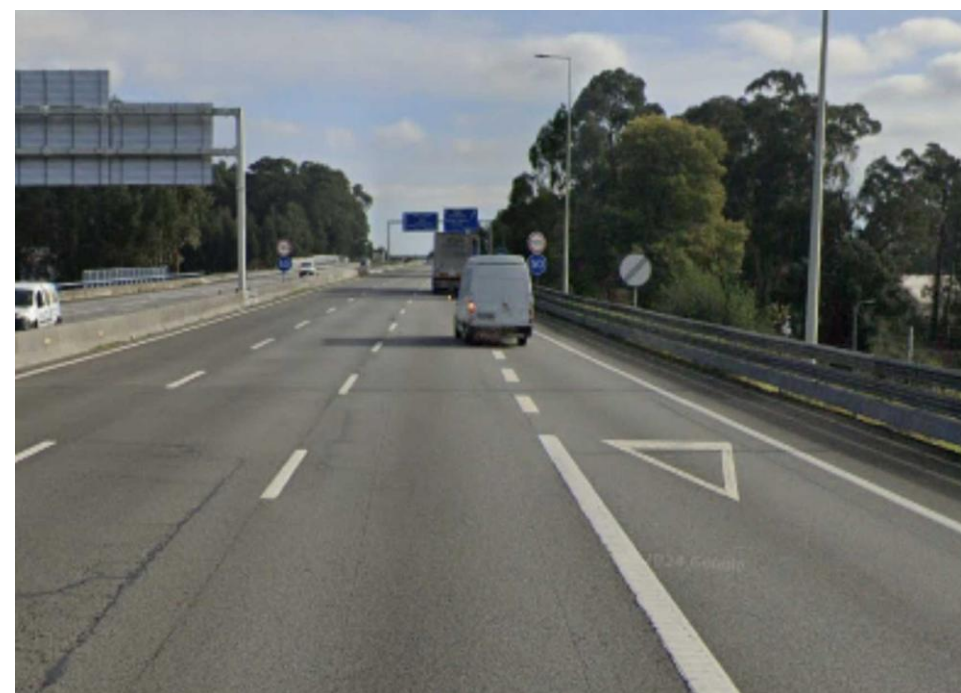
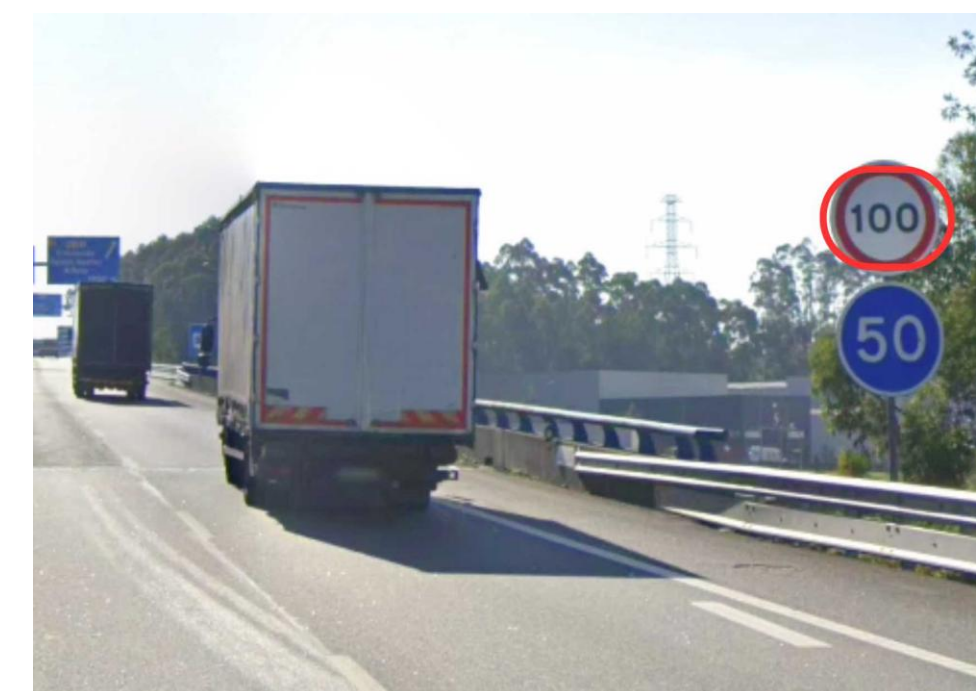
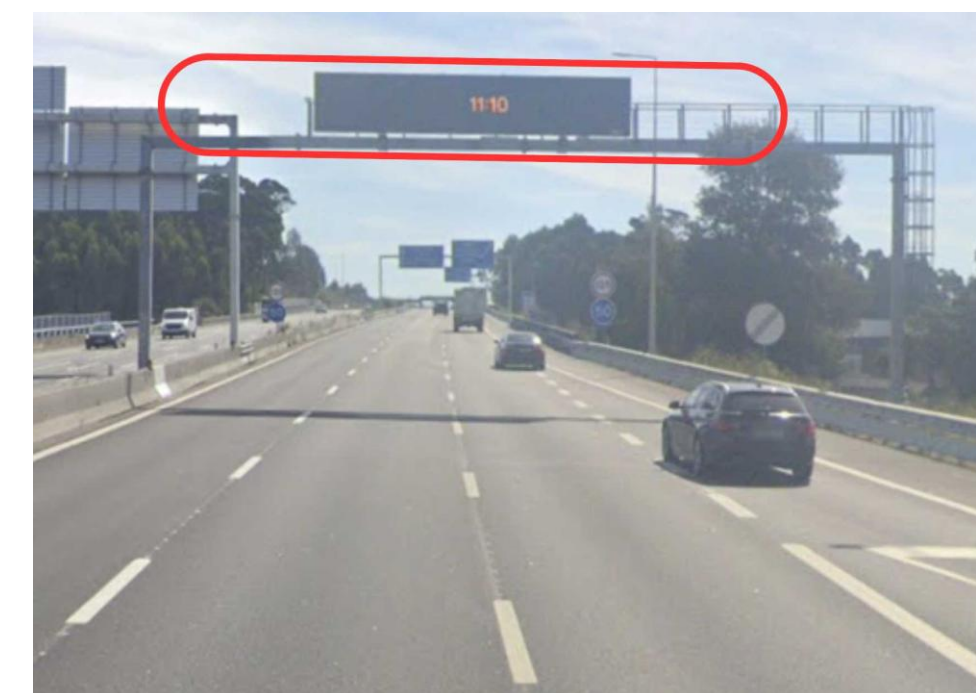
# Maia - Alfena

Grande Porto concession, A42 motorway, direction:  
increasing from PK 12+448 to 14+645

- ▲ 76 total crashes
- ▲ 38 injury crashes
- ▲ 2 seriously injured and 62 slightly injured
- ▲ 86% of crashes are vehicle to vehicle collisions

Reduction of the legal speed limit from 120km/h to 100km/h

Variable Message Sign (VMS) was installed in March 2024

Horizontal road markings with rumble strips and added lane-selection arrows

Implementations were completed on 28/11/2022.  
The VMS was installed in March 2024.

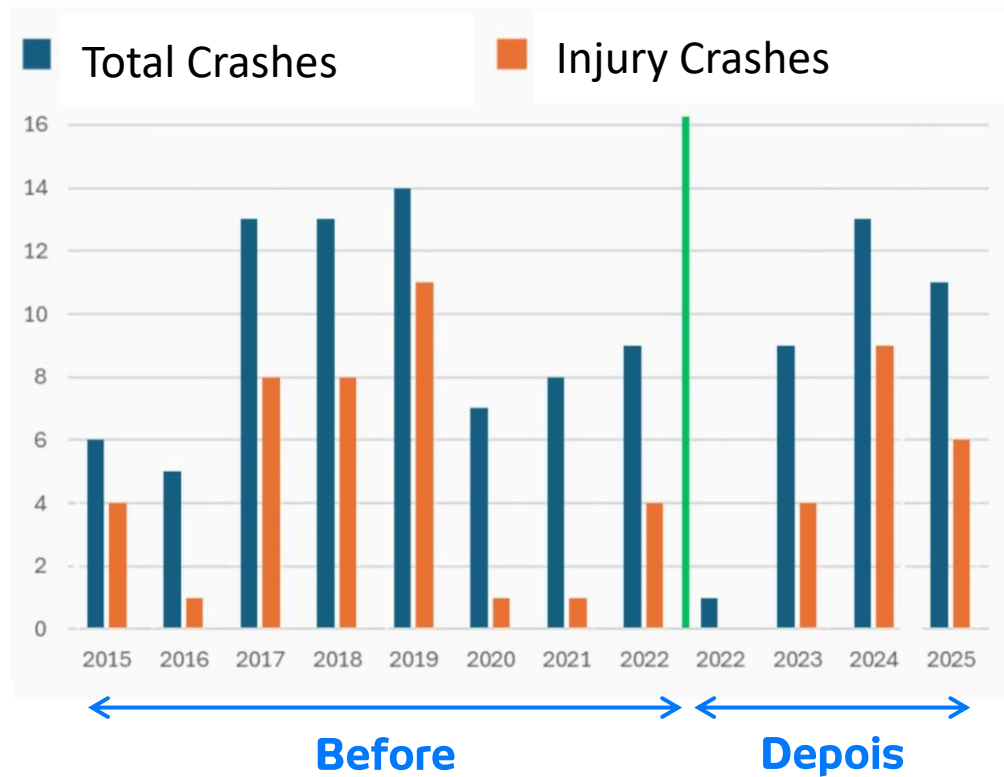
## Crash History

— Implementation date: 28/11/2022  
 After Period: 4 years, 1 month and 2 days

Before	After	Expected After	Variation	Crash Variation (%)
Crashes	76	34	30	+4	+13%
Injury Crashes	38	19	15	+4	+25%

Before	After	Weighted AADT Before	Weighted AADT After	Expected After *	Variation	Crash Variation (%)
Crashes	76	34	18614	25101	39	-6	-16%
Injury Crashes	38	19	18614	25101	20	-1	6%

**Phase 2 measures: Installation of an instantaneous speed camera and widening of the Alfena Node exit, supported by a completed traffic study, if the implemented measures prove ineffective.**

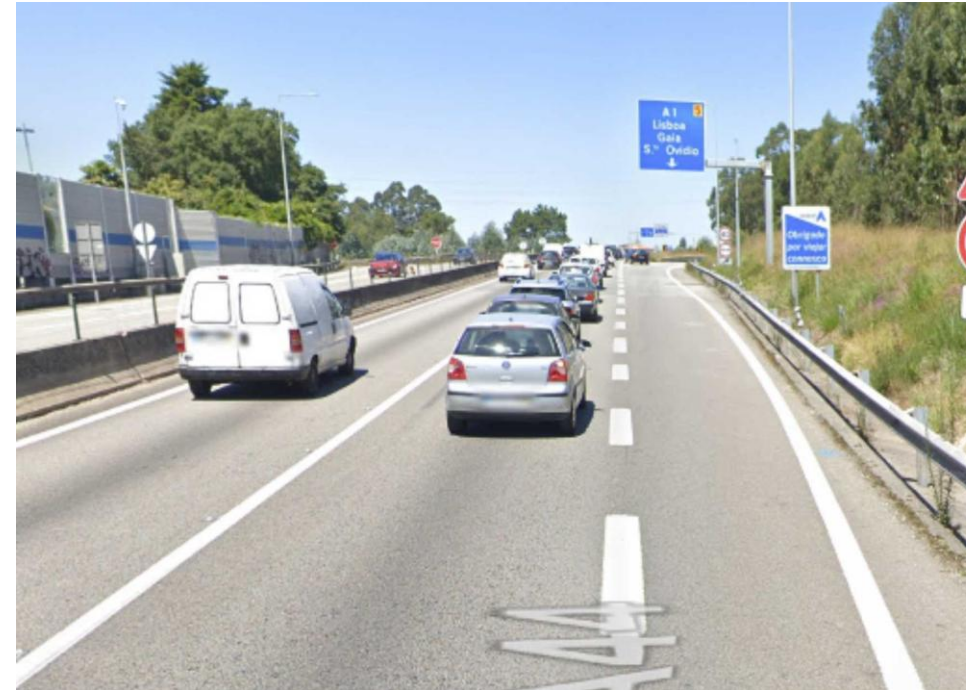
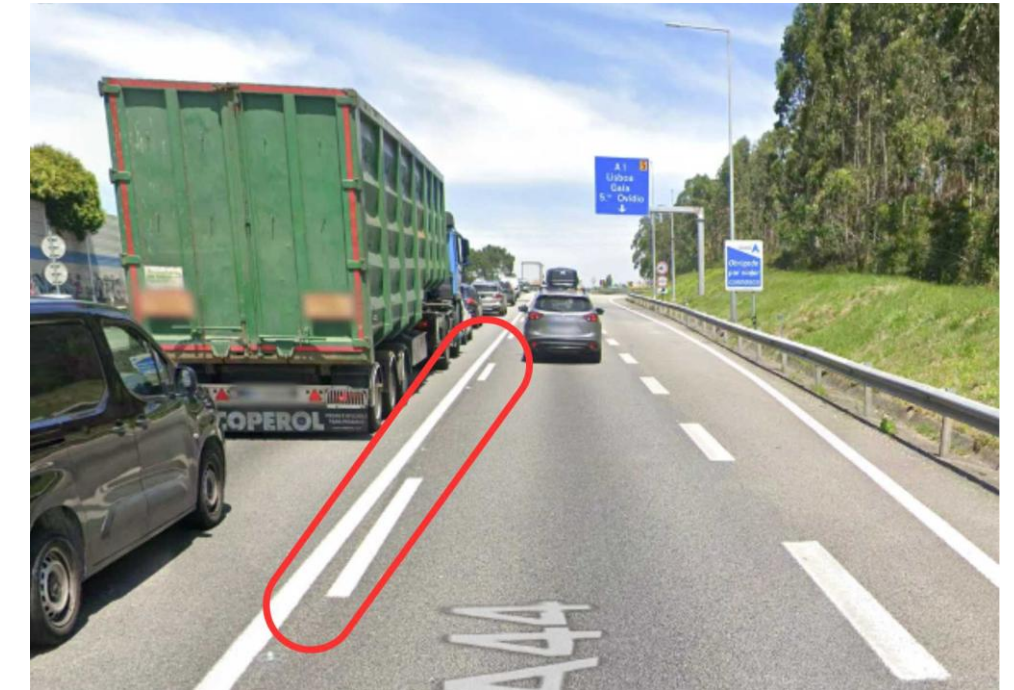
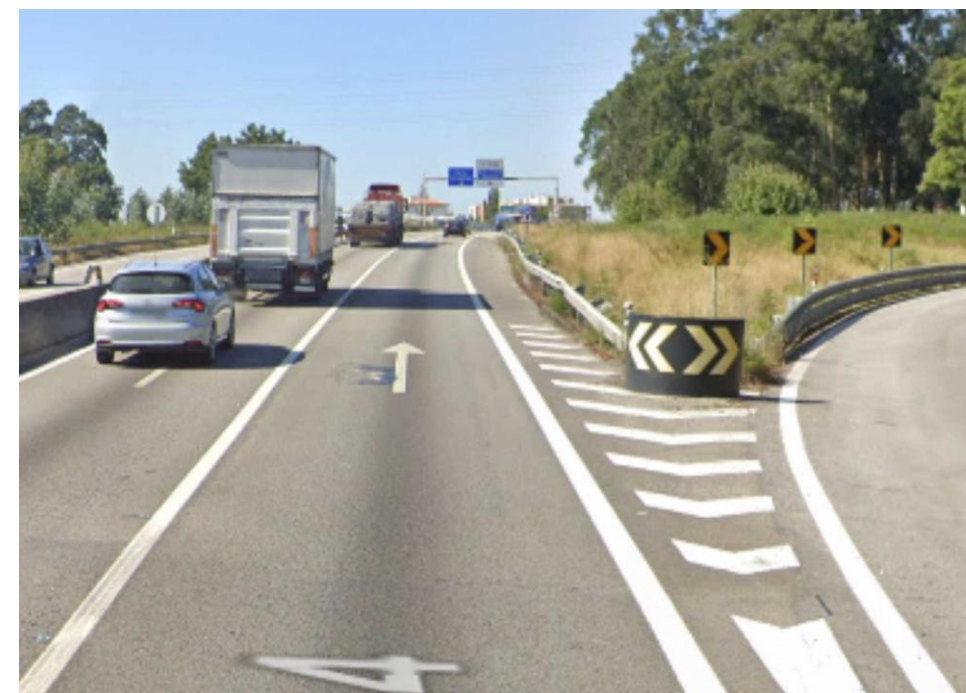
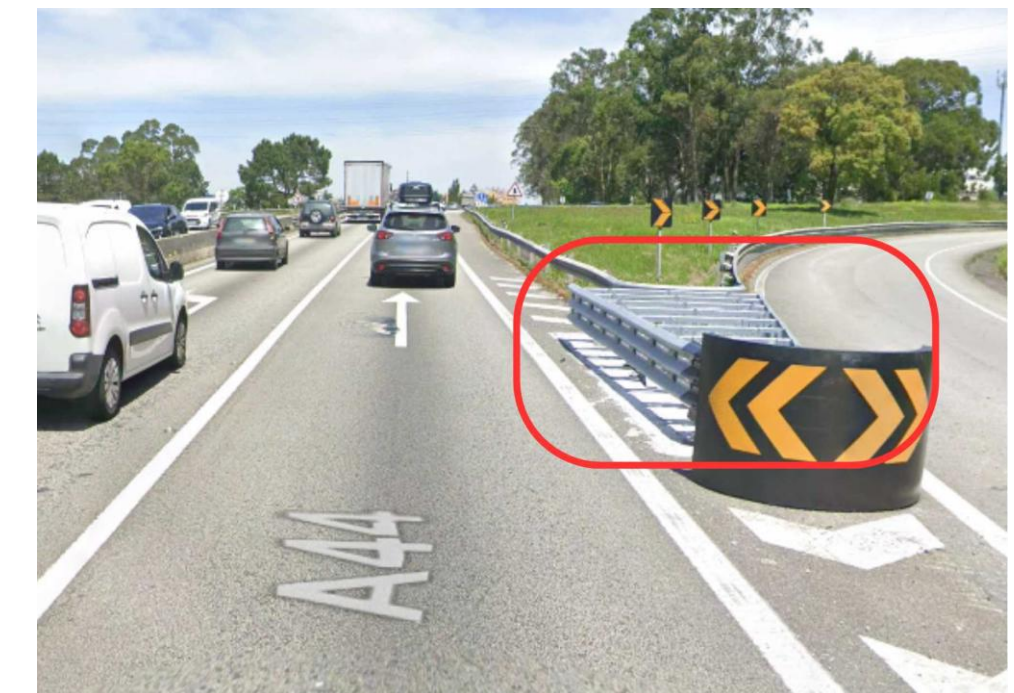
# Madalena - Coimbrões

Costa de Prata concession, A44 motorway,  
direction increasing from PK 3+103 to 3+927

- ▲ 97 total crashes and 53 injury Crashes
- ▲ 1 Mortal Victim
- ▲ 5 seriously injured and 85 slightly injured
- ▲ 97% of crashes were vehicle to vehicle collisions

Pavement rehabilitation to improve skid resistance.

Installation of a Variable Message Sign (VMS) on PK 1+100.

Installation of an impact attenuator at the diverge point.

CCTV Camera on Coimbrões Node (PK 3+650) and queue detection sensor for congestion warning.

Implementations were completed on 01/06/2024.  
The CCTV camera was installed on 4 november 2025.

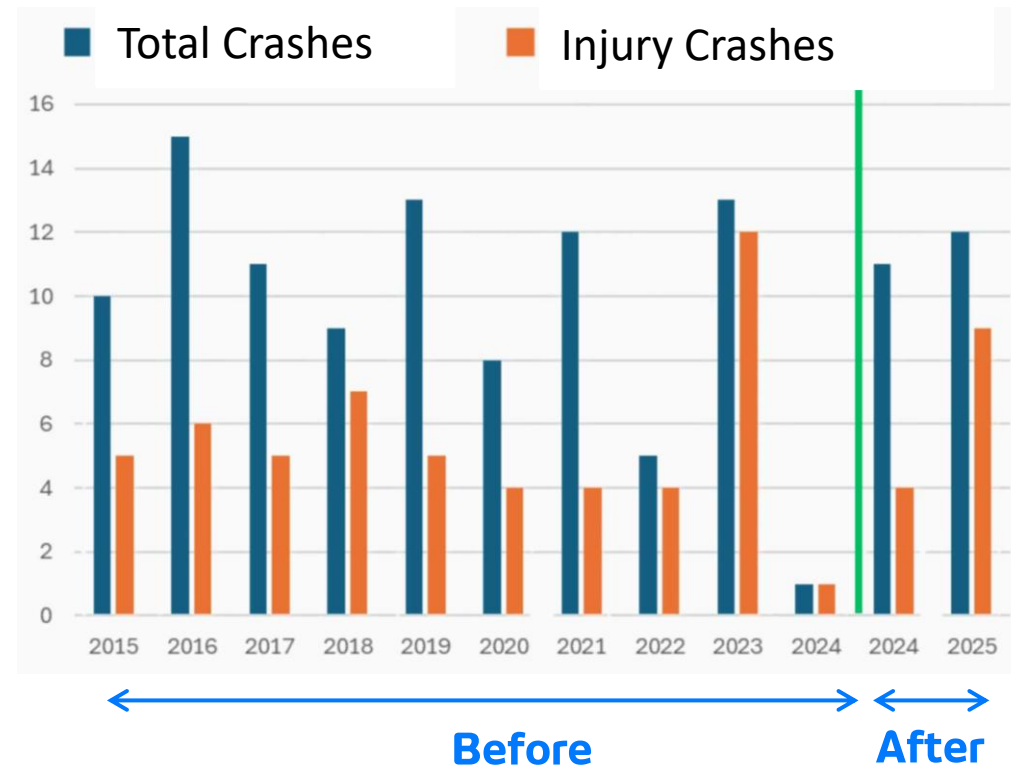
## Crash History

— Implementation date: 01/06/2024  
 After Period: 1 year and 6 month

Before	After	Expected After	Variation	Crash Variation (%)
Crashes	98	24	16	+8	+54%
Injury Crashes	53	13	9	+4	+43%

Before	After	Weighted AADT Before	Weighted AADT After	Expected After*	Variation	Crash Variation (%)
Crashes	98	24	43627	40485	15	+9	+55%
Injury Crashes	53	13	43627	40485	8	+5	+54%
